REPORT NO. NADC-87036-60

## MICRODAMAGE IN SLIDING CONTACTS

Paul J. Kennedy  
Air Vehicle and Crew Systems Technology Department  
NAVAL AIR DEVELOPMENT CENTER  
Warminster, Pennsylvania 18974

FINAL REPORT  
AIRTASK NO. A-320-320A/001-B/1F61-5442-000  
WORK UNIT ZM510

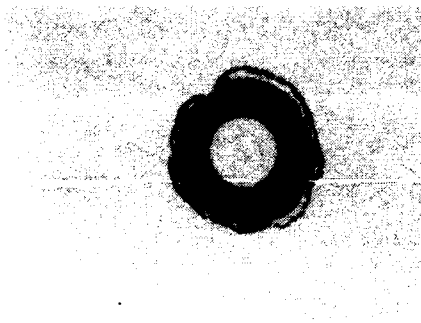
(a) 0.1  $\mu\text{m}$  SLIP (3 HOURS)

(b) 1.0  $\mu\text{m}$  SLIP (3 HOURS)

(c) 2.5  $\mu\text{m}$  SLIP (3 HOURS)

(d) 4.0  $\mu\text{m}$  SLIP (1 MINUTE)

Figure 3 - Wear scars illustrating the effect of slip amplitude on scar dimensions and type of surface damage.  
Scars are on SAE 52100 steel flats at X100 magnification.

Wear scars, similar to those predicted on the basis of the elastic analysis in Fig. 2 are shown in Fig. 3. Both the locked or inner circular region and the slipped or the outer ring region can be seen in each of these photos. The absence of surface damage in the locked region can be seen in photomicrograph (a) since small surface scratches in the locked region were not obliterated during testing. These wear scars were formed by loading a 12.7 mm diameter SAE 52100 steel ball against a SAE 52100 flat under 9 kg load and subjecting the ball/flat combination to an oscillatory twisting type of motion equivalent to the amount of slip indicated under each photo in Fig. 3. Similar wear scars were formed on the SAE 52100 ball specimens. The outer diameter of these scars are approximately 0.3 mm and correspond to that which would be predicted on the basis of the Hertz equation. The slip amplitudes indicated under each of the photomicrographs in Fig. 3 were calculated at the Hertz radius from the angle of twist. These wear scars, although they were part of a previous study (1), clearly illustrate some of the changes in wear scar characteristics that are slip amplitude dependent. Photo (a) shows that surface straining or very mild oxidation can occur at a slip of 0.1  $\mu\text{m}$ . Based on this measurement and wear tests at lower amplitudes, the minimum amount of microslip capable of producing surface oxidation or straining was estimated at approximately 0.06  $\mu\text{m}$ . Surface profile measurements indicated that the amount of surface damage was minimal in photos (a) and (b) but significant in photo (c). This later photo also shows a ring of wear debris around the wear scar. This data indicates that considerable surface damage can occur at slip amplitudes as small as 2.5  $\mu\text{m}$ .

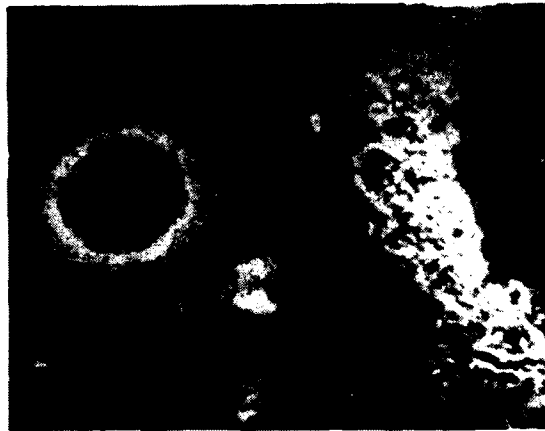
(a) DAMAGE AT 1.43  $\mu\text{m}$  SLIP (1 MINUTE)

(b) DAMAGE AT 1.90  $\mu\text{m}$  SLIP (1 MINUTE)

(c) DAMAGE AT 2.85  $\mu\text{m}$  SLIP (1 MINUTE)

Figure 5 - Wear scars illustrating the development of surface damage under conditions of small amplitude slip.

The lack of good explanations for these findings prompted further study of the effect of low amplitude slip on the fretting process. The primary emphasis in our more recent work was to determine if the presence of wear debris in the inner ring region might influence the normal stress distribution in the ball/flat contact region. For example, wear debris that collects near the edge of the wear scar could result in a pressure spike in the normal stress distribution and this could possibly result in the formation of an additional locked area. With this in mind, a series of fretting experiments were conducted at very short durations with the intent of eliminating or greatly reducing the effect of wear debris. Photomicrographs from this study are shown in Fig. 5. These wear specimens were limited to 12,600 fretting cycles to reduce wear particle build-up. The general absence of wear debris in these photomicrographs also has the advantage of clearly showing topographical features that were not evident in the previous study. Photo (a) shows a typical wear scar formed under low amplitude slip for a short test duration. This wear scar consists of an oxide ring corresponding to the outer diameter of the Hertzian contact region. Surface profile measurements did not indicate any measurable surface damage. The wear scar in photo (b) was produced at a higher slip amplitude and shows evidence of surface roughening not seen in the photo (a). This surface roughening consists of small depressions and raised areas. Photo (c) at still higher amplitude slip shows evidence of the development of a thin polished band between the roughened inner ring and an outer ring consisting of extruded wear debris.

Amplitudes larger than those shown in Fig. 5 were found to produce wear scars that showed unusual and difficult to explain surface characteristics. These scars show the same undamaged region and three distinct wear regions that were previously noted in Fig. 3 but with much better resolution. These regions are numerically labeled in photo (a) of Fig. 6. Region 1 is the locked region that would be expected on the basis of elastic theory. Surface texture in this region is identical to the undamaged surface of the flat outside of the contact zone. Regions 2 and 3 combined form the slipped region. Region 2 can be seen as distinct from region 3. It forms a relatively wide, rough region that has the appearance of an inner ring. Region 3 which is actually a very thin polished band, is clearly visible at 500X magnification in photo (a). Region 4 defines the outer edge of the wear scar. In this region, photo (a) shows that the wear debris is in the form of a very thin extruded sheet of material. This wear debris partially hides a groove that forms a ring around the wear region. This last region can be called a ring groove region.

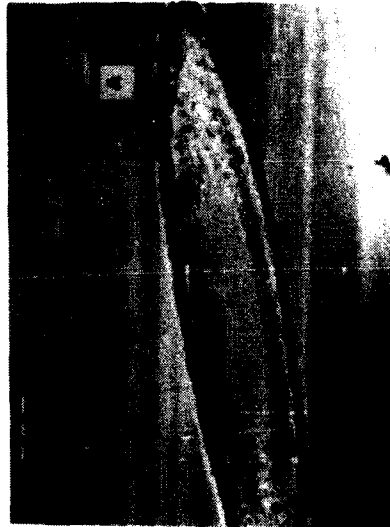
Figure 6 - Photomicrographs of wear scar formed at 3.8  $\mu$ m slip which illustrate four numerically labeled wear scar regions that include (1) a locked region, (2) an inner ring, (3) a thin outer or polished ring and (4) a ring groove region.

The inner ring or region 2 can be seen more clearly in Fig. 6, photo (b) using different illumination. Close examination of photo (b) suggests the presence of numerous elongated holes. These holes also appear to be in an axial direction or elongated in the direction of slip. This was not observed in the previous study(1) since the larger part of that work involved testing in excess of 2 million fretting cycles. Only 12,600 cycles were used in this study. Long testing would be expected to result in the obliteration of this pitted appearance. Region 3 is not highly visible in photo (b). The remaining two photomicrographs in Fig. 6 focus on the morphological features of region 2 and 3. Photo (c) is the same wear scar taken at an oblique angle. This photo shows the morphology of the wear scar and indicates the general area shown in photo (d). This last photo shows a close-up of the polished region taken at an oblique angle. This thin polished band, shown in the middle region of photo (d), can be seen as a region in which the metal surface has been flattened or polished smooth. This suggests that considerable slip had occurred in this third region. This division of the slipped region into two distinct wear regions may be related to normal and shear stress distributions in that region 2 is a low slip, high stress while region 3 is a high slip, low stress area.

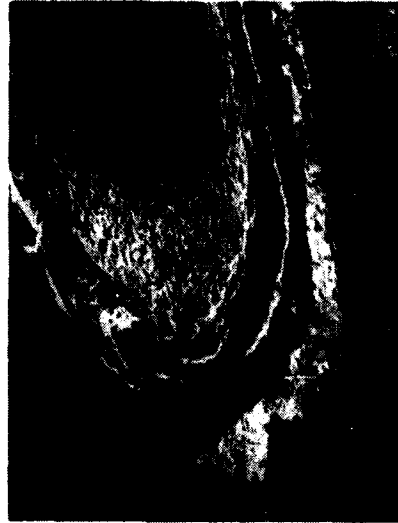
Figure 7 - Photomicrographs of wear scars formed at 4.3  $\mu$ m slip showing region 4 or the ring groove region.

Ring groove formation (region 4) is more clearly seen in Fig. 7. The photomicrographs are wear scars generated at  $4.3 \mu\text{m}$ . Photos (a), (b) and (c) are of wear scars formed after 126,000 fretting cycles; photo (d) represents 378,000 cycles. Photo (a) shows extrude wear debris over the groove. Higher magnification photos in (b) and (c) shows the contour of the groove. The inner side of the ring groove in photo (c) can be seen to be fairly steep. This ring groove represents an interesting phenomenon and can be probably attributed to the interaction of a torsional force with the tensile stresses ( $0.13$  maximum pressure) existing outside of the Hertzian contact region. This ring groove is amplitude dependent. This dependency was quantified by nital etching of test specimens. Examination of test specimens generated at different slip amplitudes after nital etching indicated that the ring groove first developed at a slip amplitude of approximately  $1.9 \mu\text{m}$  under a  $9 \text{ kg}$  load. Studies of the effect of time on ring groove development suggest that the outer diameter of the groove increases with time. The groove, in turn, tends to collect the wear debris extruded out of the contact region. This debris can be seen at the bottom of the ring groove in photo (d). Examination of wear scars formed after 2,000,000 or more fretting cycles indicates that the ring groove will eventually become completely filled with extruded wear debris.
